TECHNICAL MEMORANDUM 1397

INTERIM REPORT ON FATIGUE CHARACTERISTICS OF A TYPICAL METAL WING

By J. L. Kepert and A. O. Payne

Aeronautical Research Laboratories
Melbourne, Australia

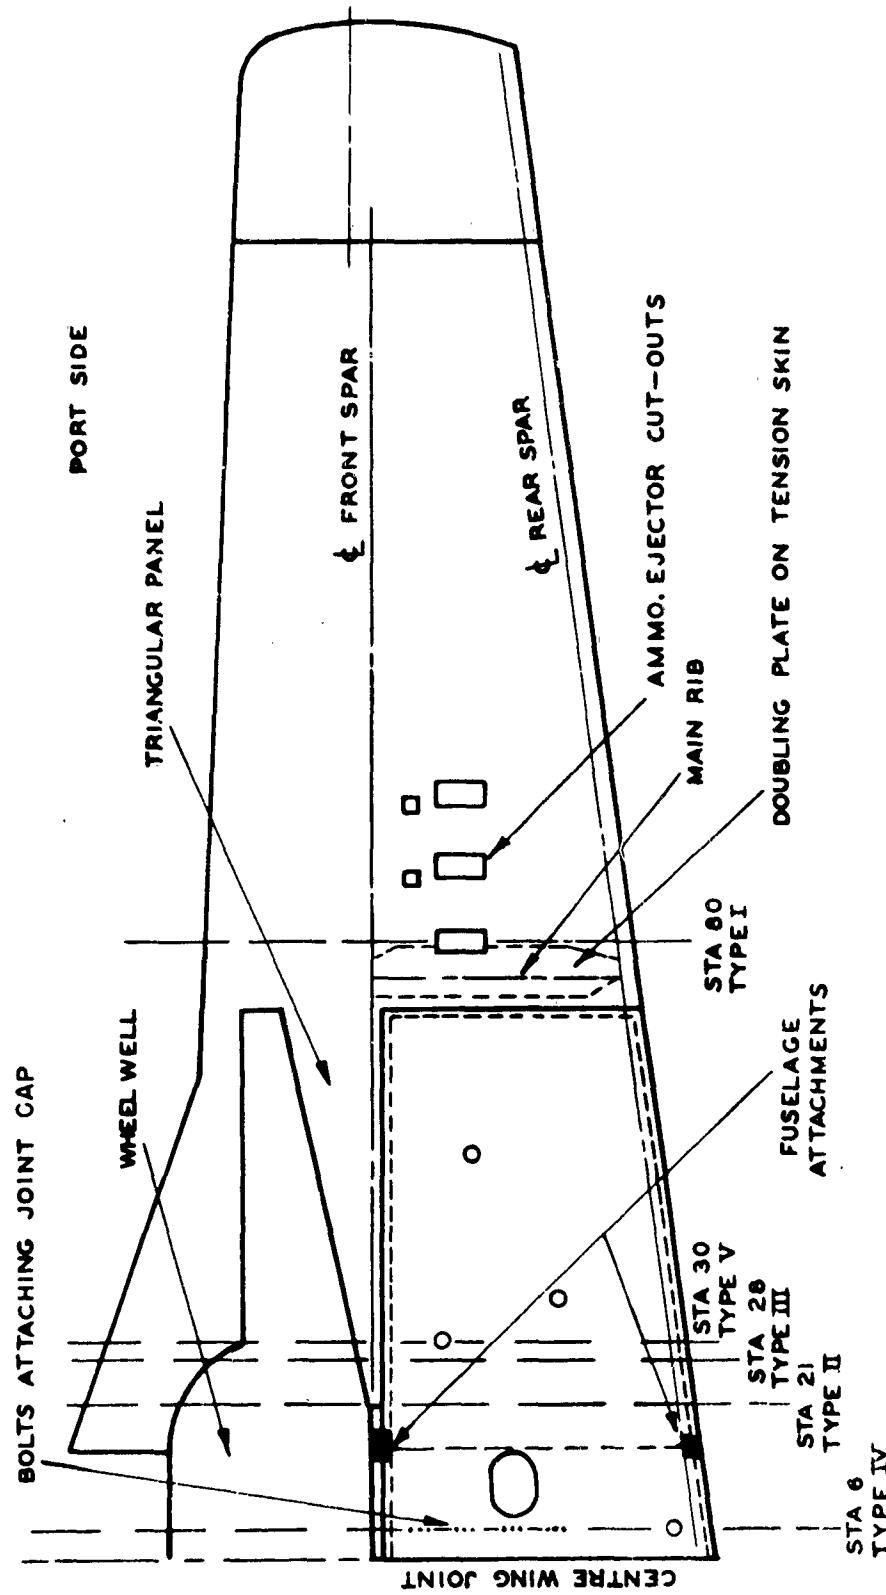
Six distinct types of failure have been observed at positions indicated in figure 5. These can be summarised as:

I. Failure initiating in the skin at station 80 from the leading edge of the ammunition chute.

II. Failure in the region of station 21, originating from the junction of the wheel-well panel with the front spar.

III. Failure in the region of station 28 originating from the front spar flange where the spar doubler ends.

IV. Failure in the region of station 6 originating from holes required for the bolts attaching the joint cap at the centre joint.

V. Failure initiating similarly to III in the region of station 35.

VI. In pre-loaded wings only; failure in the upper flange of the front spar at station 77, leading to failure in the lower flange and then forward into the skin from the front outboard corner of the tank-bay. The failures are described in detail in appendix III.

Figure 5.- View of wing lower surface showing position of major failures.

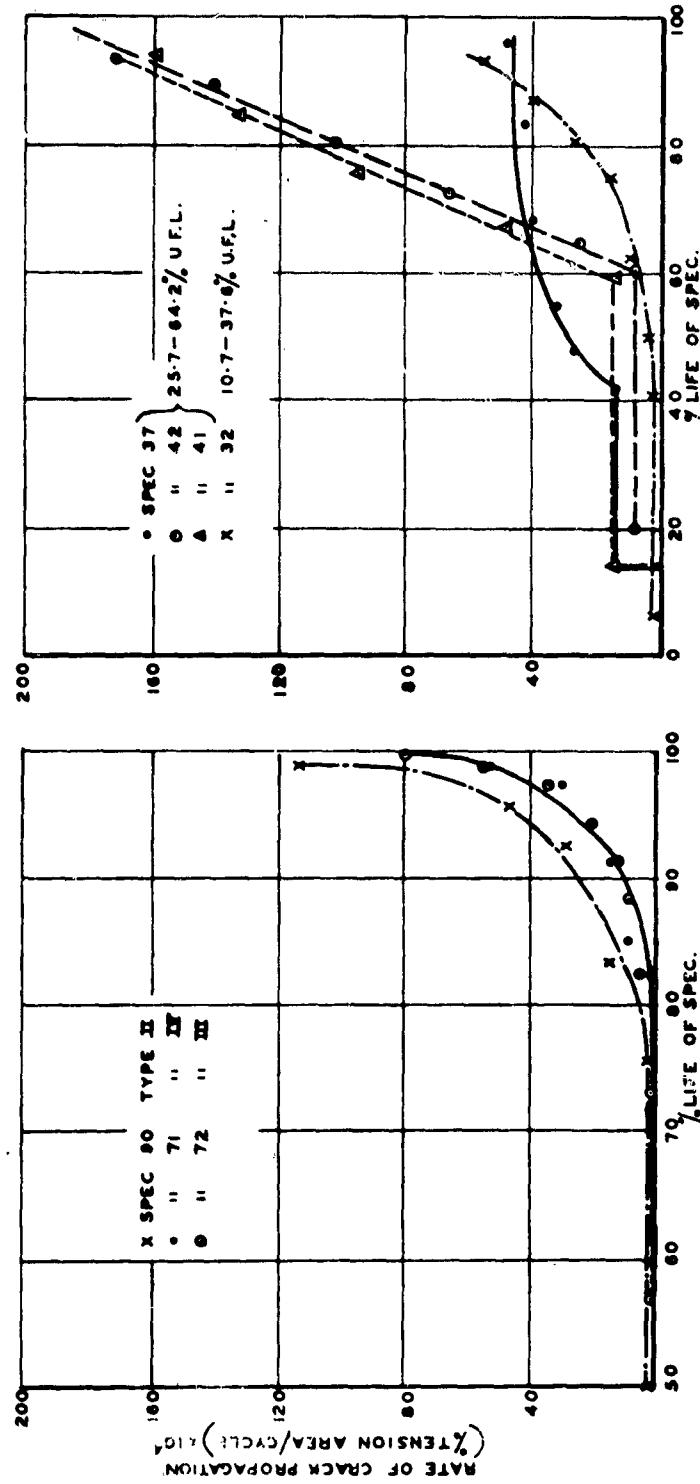
The rates of crack propagation at the major failures are shown in figure 14 and 15 from which it will be observed as noted in reference 1 that crack propagation rate (measured as the percentage of initial tension area failing per cycle) is constant for a large part of the total life.

- (c) The rate of crack propagation at the major failures (percentage of initial tension area failing per cycle) is approximately constant for a large part of the life (figs. 14 and 15).

Figure 14.- Crack propagation rate.
Failure types II, III, IV.Figure 15.- Crack propagation rate.
Failure type I.

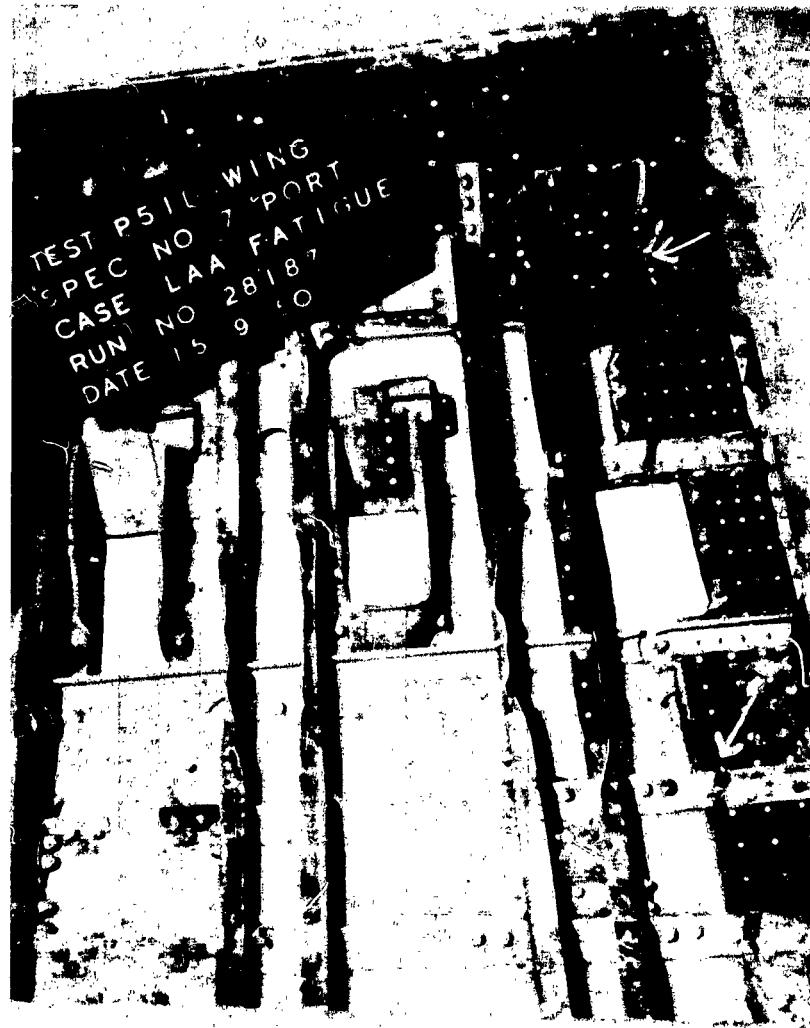
Figure 18.- Failure at station 80 - type I. Inner surface.

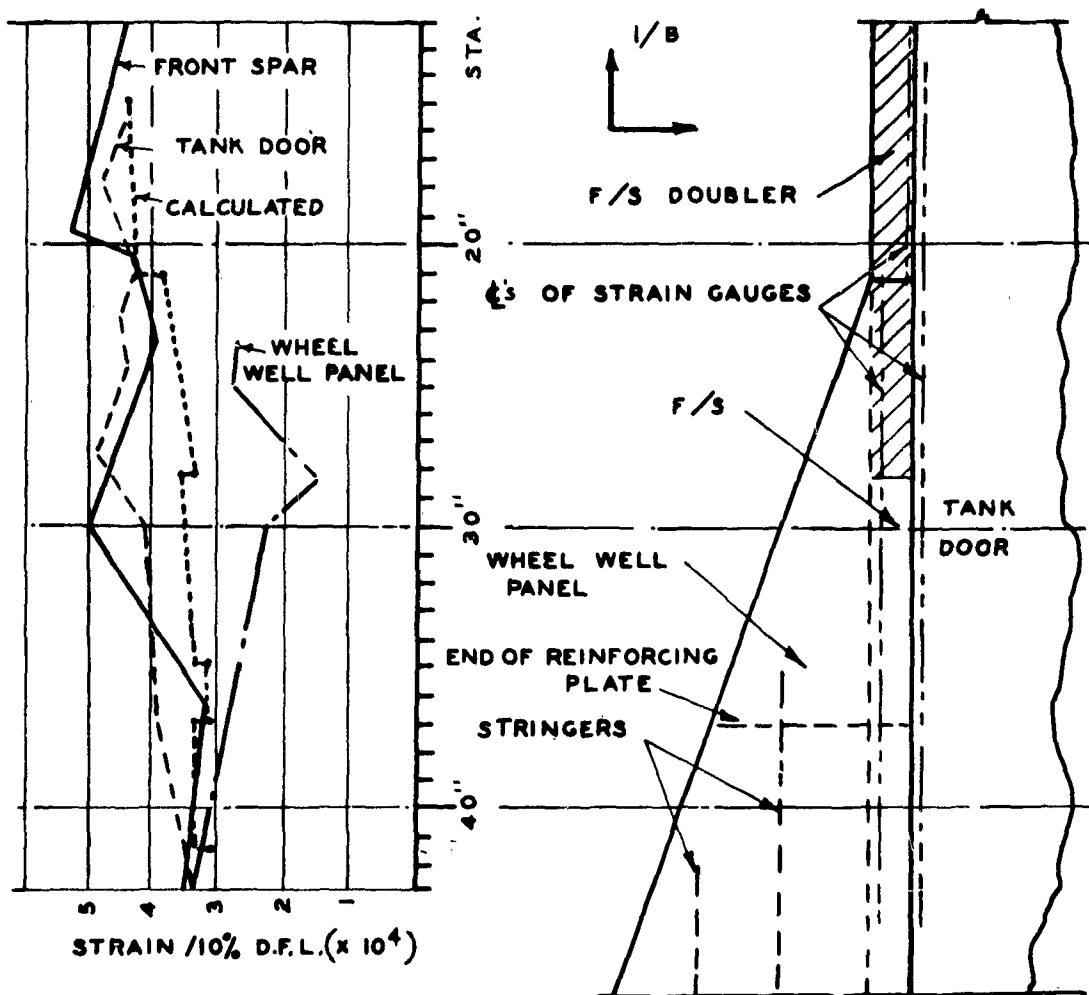
The strain distribution in the critical area of the tank-bay is shown in figure 33. These readings were taken in the region of the front spar between stations 15 and 40 where the failures II, III, and V develop.

The strain distribution along the front spar between station 15 and station 42 is shown in figure 33. These results have been obtained from electric resistance strain gauges attached to the main spar flange, the tank-bay door, and the skin panel attached to the front spar flange rear of the wheel well. This is the region in which failure types II, III, and V originate.

point and station 20, the stress carried in the skin panel falls off considerably causing a corresponding rise in the stress in the main spar flange. These results show that the major fatigue failures occur at points where there is a peak in the local stress level.

Figure 33.- Strain distribution in region of front spar in neighbourhood of station 28.
